RE Final Report for the Round 4 AMP Grant
Project Number BWR 2018 – 04
Project Name: Water Infrastructure Assessment and Planning Grant
Wareham Fire District – Water Department

Title: Leak Detection and Condition Assessment

Client: Wareham Fire District Water Department

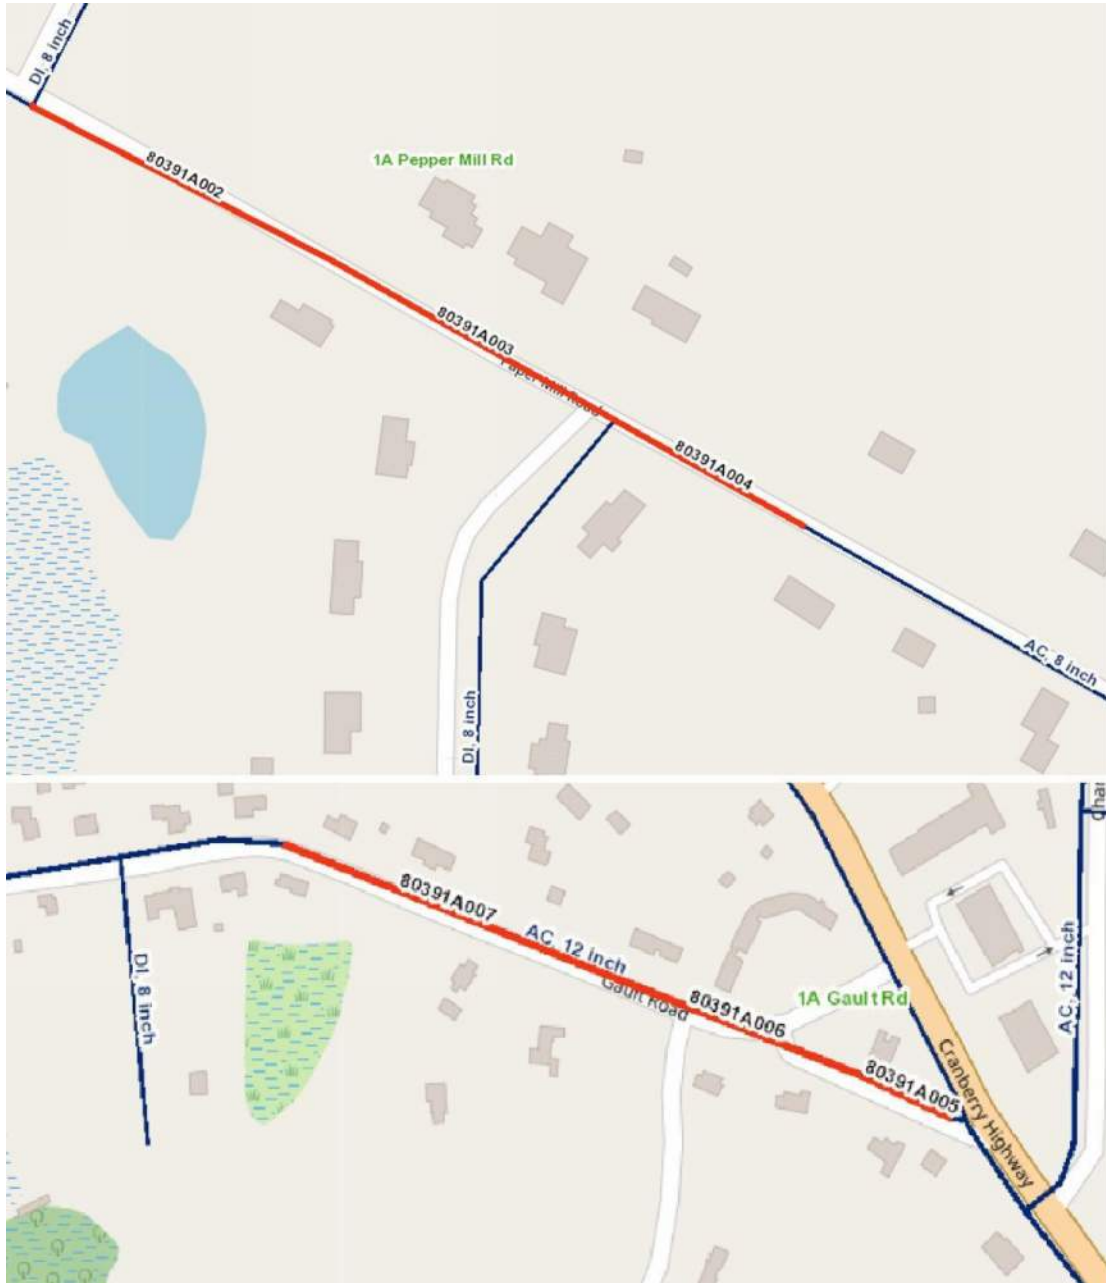
Figure A.4-1: Map illustrated qualitative ePulse® results for Site 1

ePulse® results indicate that both the 8-inch AC main and the 12-inch AC main are in poor condition with 31% to 46% loss in structural wall thickness. Wall thickness measurements range from 0.51 to 0.52 inches for the 8-inch main and from 0.59 to 0.72 for the 12-inch one. The site-specific results are listed in Table A4-3 and illustrated on Figure A.4-1.

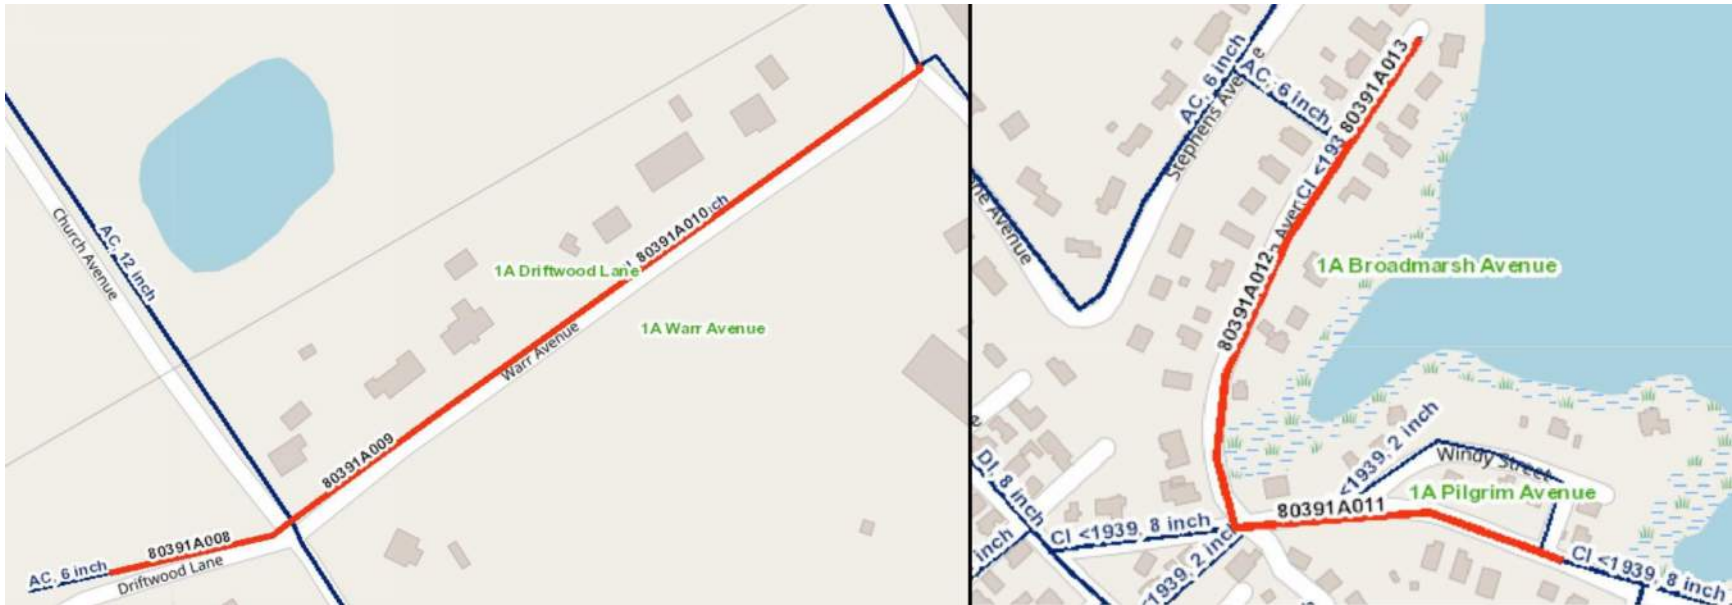
Figure A.4-2: Map illustrated qualitative ePulse® results for Site 2

ePulse® results indicate that both the 6-inch CI main and the 10-inch CI main are in poor condition with 30% to 45% loss in structural wall thickness. Wall thickness measurements range from 0.24 to 0.28 inches for the 6-inch main and from 0.31 to 0.38 for the 10-inch one. The site-specific results are listed in Table A4-4 and illustrated on Figure A.4-2.

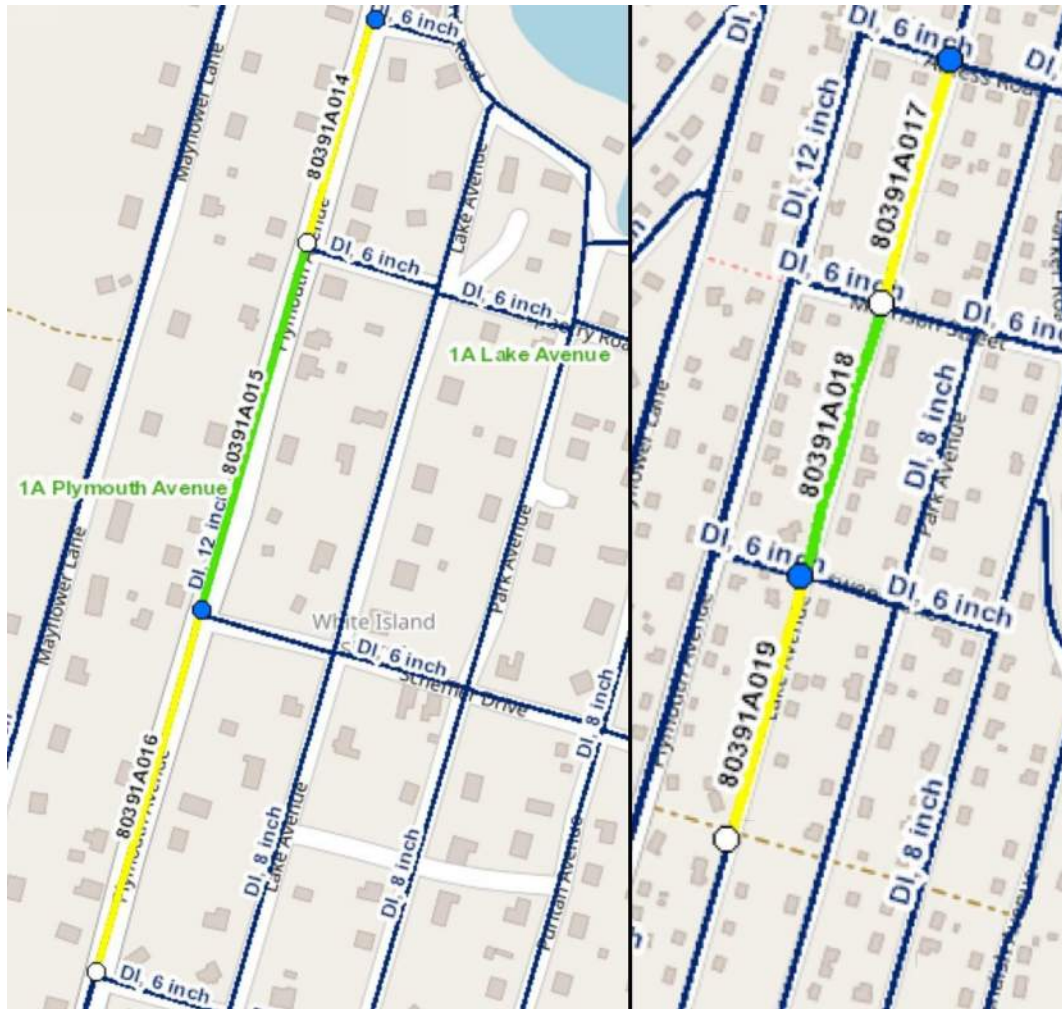
Figure A.4-3: Map illustrated qualitative ePulse® results for Site 3

ePulse® results indicate that both the 8-inch DI main and the 12-inch DI main are in good to moderate condition with 5% to 30% loss in structural wall thickness. Wall thickness measurements range from 0.26 to 0.34 inches for the 8-inch main and from 0.35 to 0.39 for the 12-inch one. The site-specific results are listed in Table A4-5 and illustrated on Figure A.4-3.

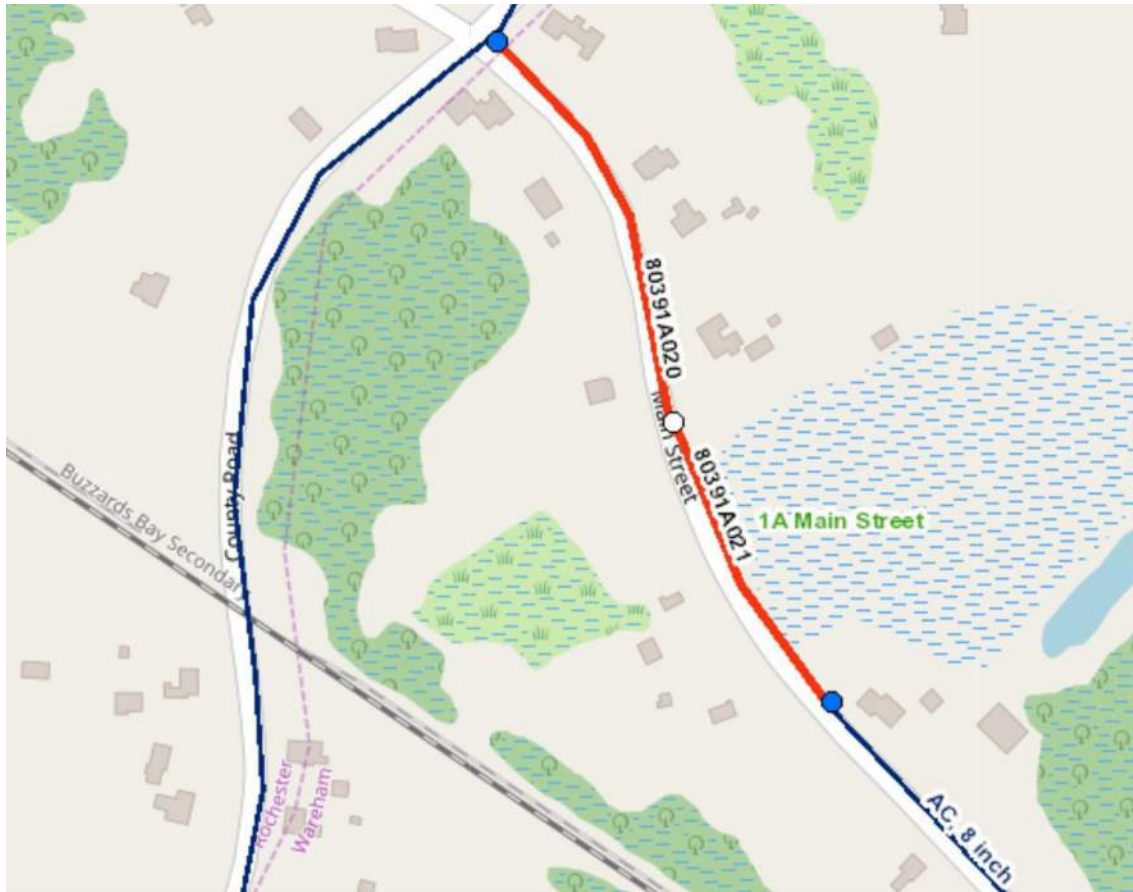
Figure A.4-4: Map illustrated qualitative ePulse® results for Site 4

ePulse® results indicate that the 8-inch AC main is in poor condition with 37% to 42% loss in structural wall thickness. Wall thickness measurements are 0.44 inches for Segment 20 and 0.48 inches for Segment 21. The site-specific results are listed in Table A4-6 and illustrated on Figure A.4-4.

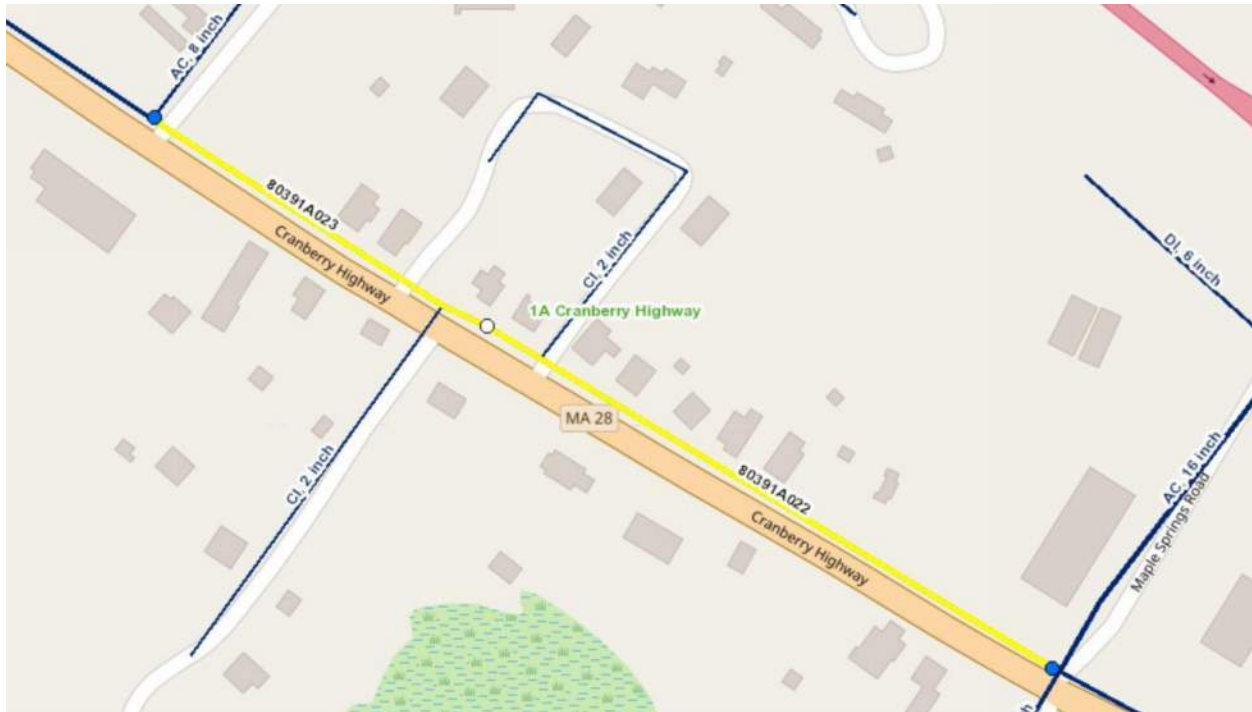
Figure A.4-5: Map illustrated qualitative ePulse® results for Site 5

ePulse® results indicate that the 10-inch CI main is in moderate condition with 15% to 22% loss in structural wall thickness. Wall thickness measurements are 0.42 inches for Segment 22 and 0.45 inches for Segment 23. The site-specific results are listed in Table A4-7 and illustrated on Figure A.4-5.

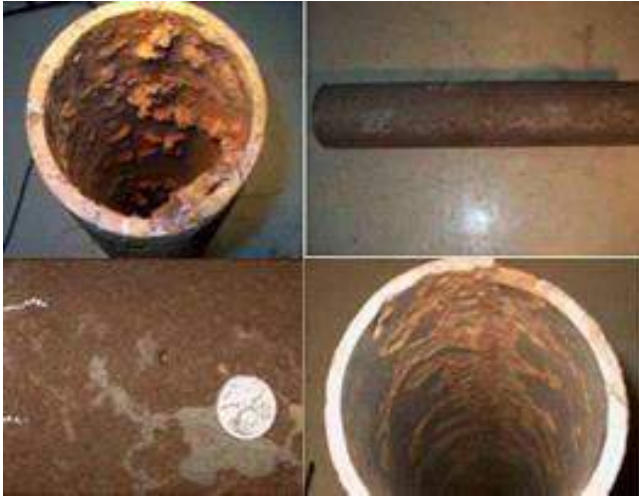
6" CI pipe with 4.2% measured loss

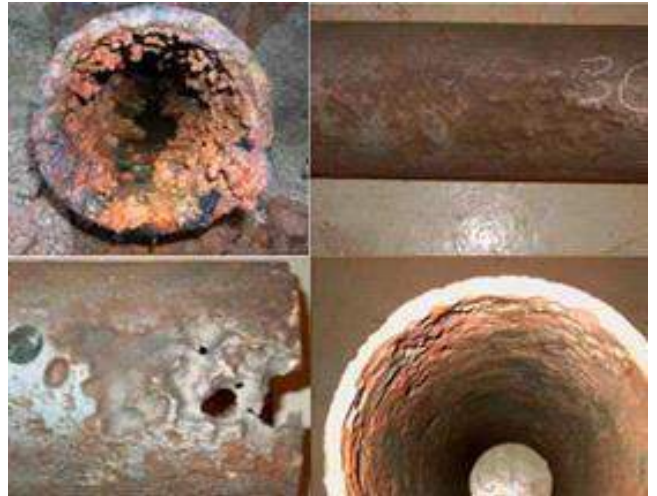
6" CI pipe with 47% measured loss

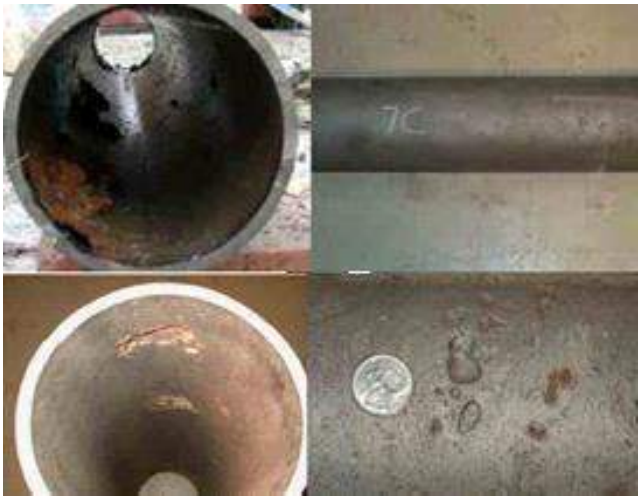
6" CI pipe with 10% measured loss

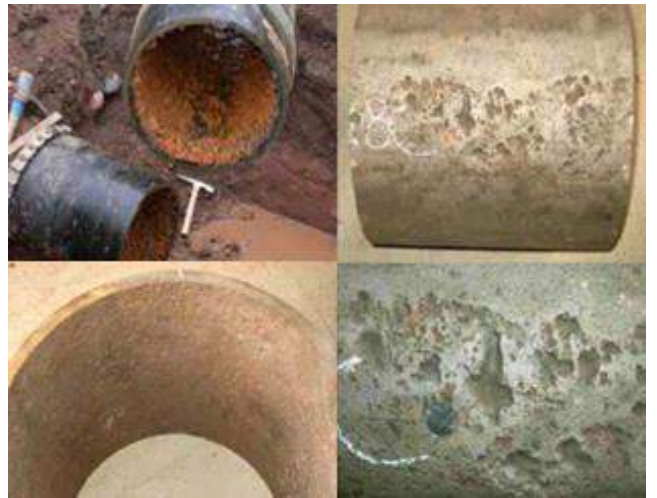
18" CI pipe with 18.5% measured loss

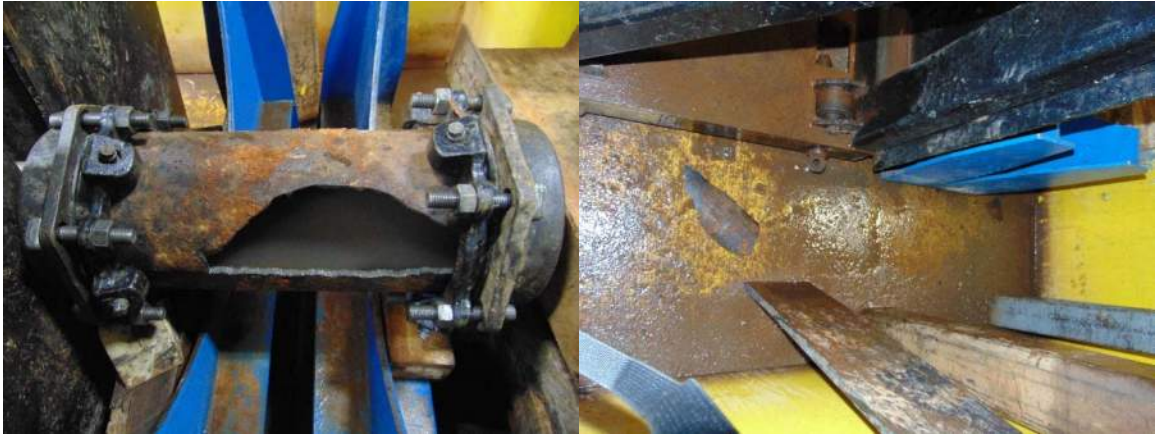
Capped, filled and pressurized to 1580 psi when the side of the sample broke out.
