RE Final Report for the Round 4 AMP Grant
Project Number BWR 2018 – 04
Project Name: Water Infrastructure Assessment and Planning Grant
Wareham Fire District – Water Department

Title: Leak Detection and Condition Assessment

Client: Wareham Fire District Water Department

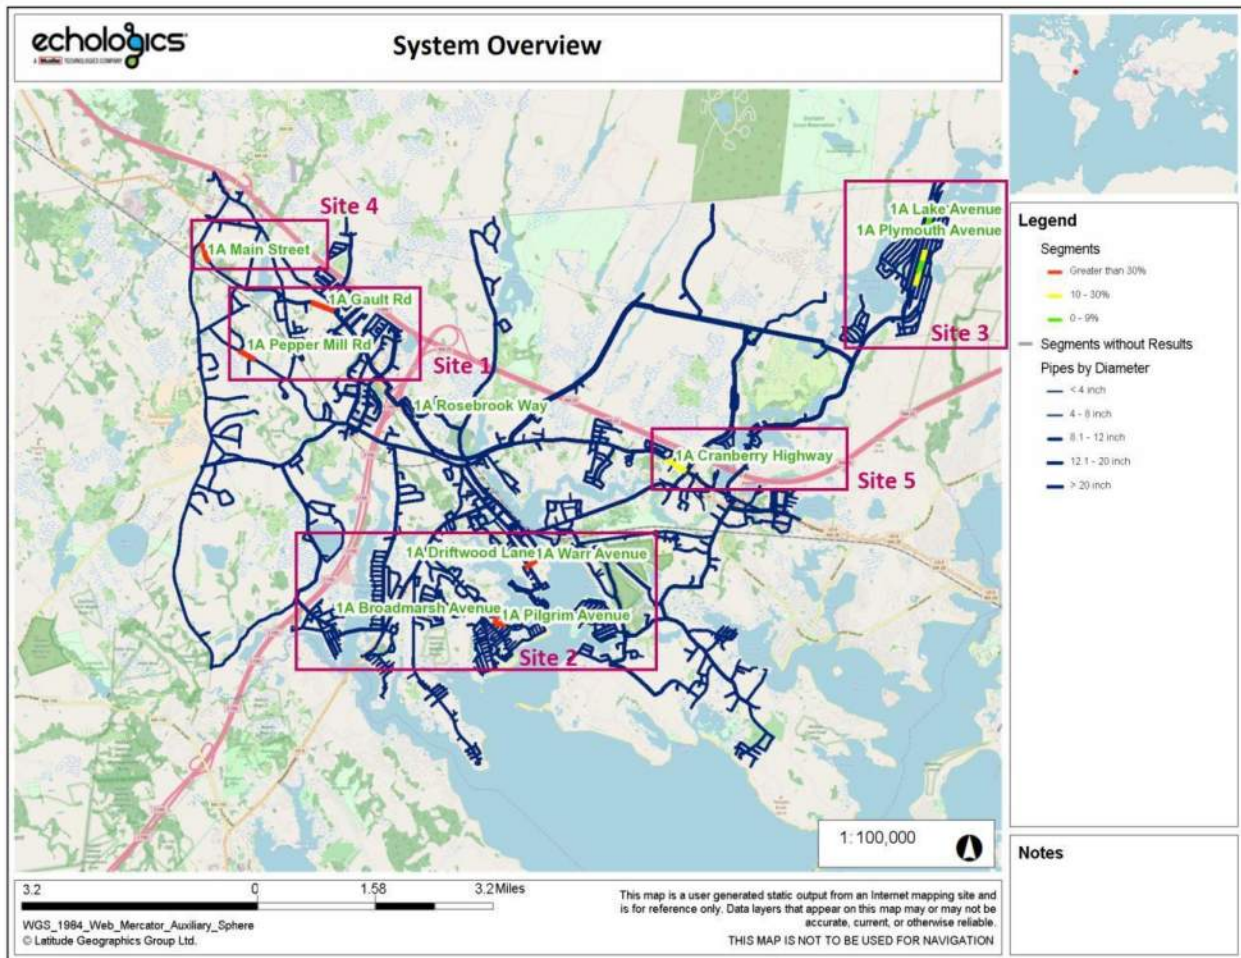
An overview map of the site along with drawn qualitative ePulse® results of the tested segments is shown in Figure A.1: System Overview and Site Locations below.

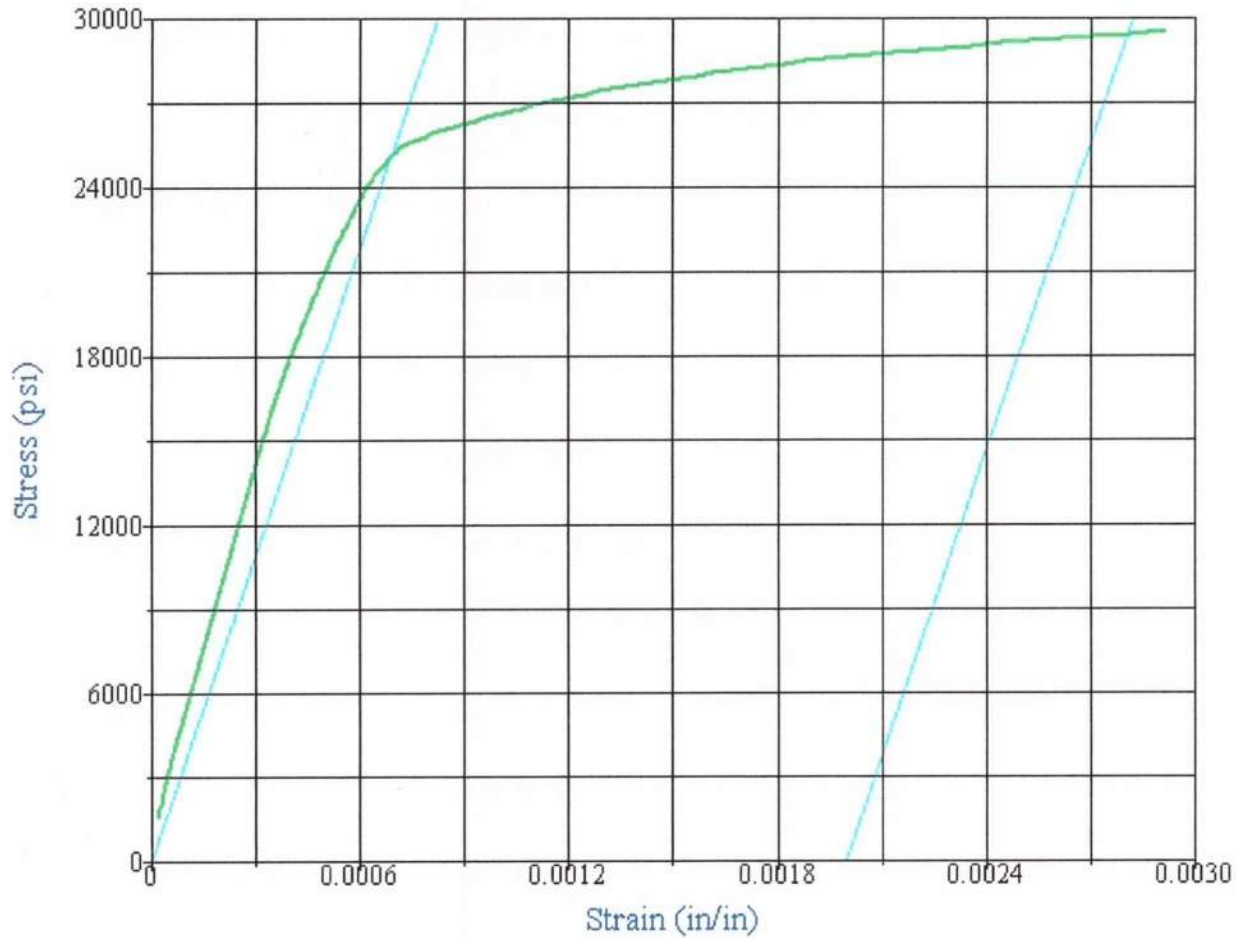
Counter: 15906
 Elapsed Time: 00:00:34
 Procedure Name: .250
 Start Date: 7/17/2018
 Start Time: 8:23:26 PM
 End Date: 7/17/2018
 End Time: 8:24:00 PM
 Workstation: Clow Water Systems
 Tested By: chad
 MyNote: product test 10 "
 PipeSize:
 CM:
 Class:

Diameter: 0.2510 in
 Area: 0.0495 in²
 Peak Load: 1461 lbf
 Secant Modulus: 36487000 psi
 Load at Offset: 1457 lbf
 Tensile Strength: 29520 psi
 Total Elongation: 2.32 %
 Pretest Punch Length: .9900 in
 Posttest Punch Length: 1.0130 in
 Stress at Offset: 29430 psi

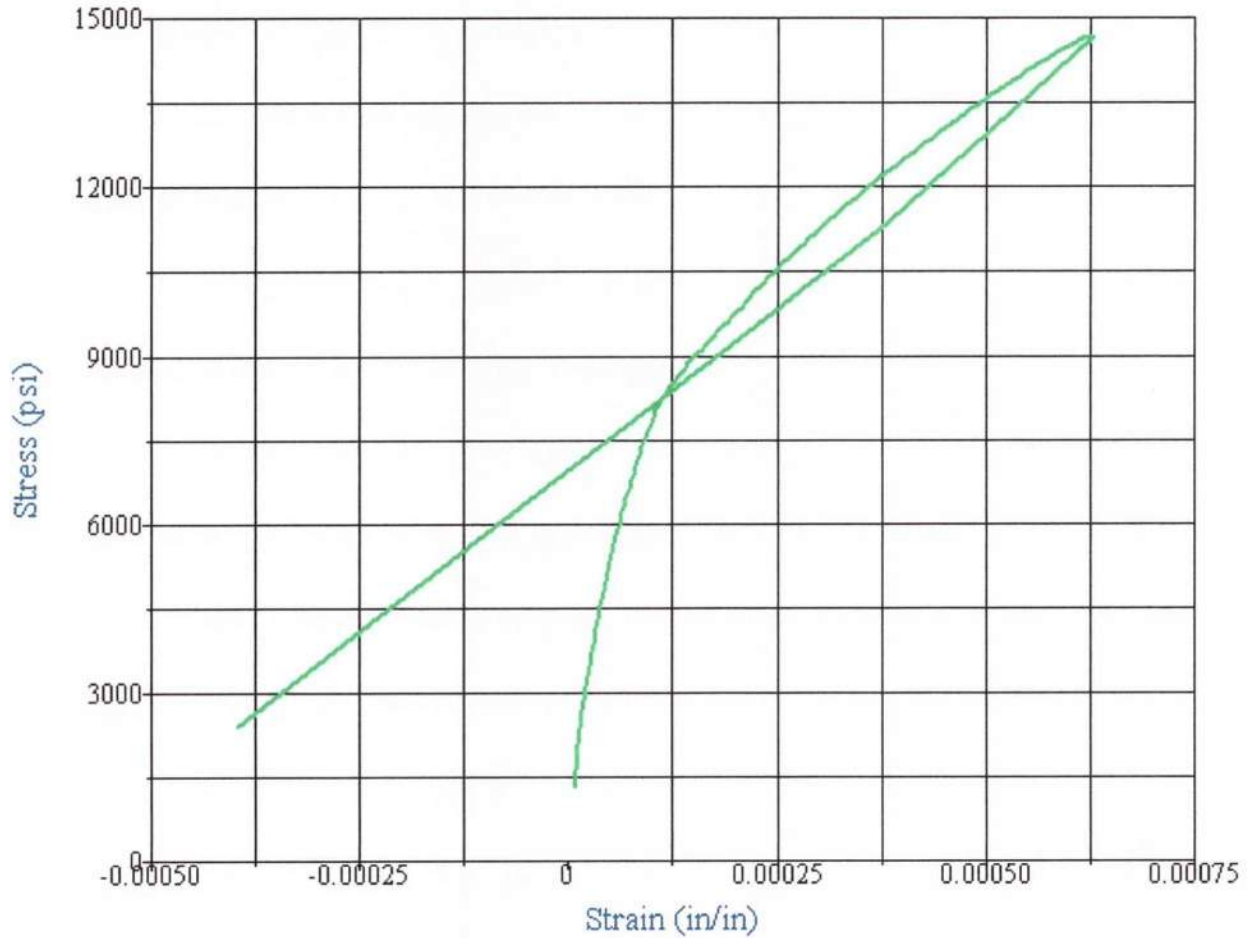
Counter: 15904
 Elapsed Time: 00:00:16
 Procedure Name: .250
 Start Date: 7/17/2018
 Start Time: 7:47:04 PM
 End Date: 7/17/2018
 End Time: 7:47:20 PM
 Workstation: Clow Water Systems
 Tested By: chad
 MyNote: product test # 2
 PipeSize:
 CM:
 Class:

Diameter: 0.2565 in
 Area: 0.0517 in²
 Peak Load: 759 lbf
 Secant Modulus: Failed
 Load at Offset: Failed
 Tensile Strength: 14680 psi
 Total Elongation: 0.81 %
 Pretest Punch Length: .9905 in
 Posttest Punch Length: .9985 in
 Stress at Offset: Failed

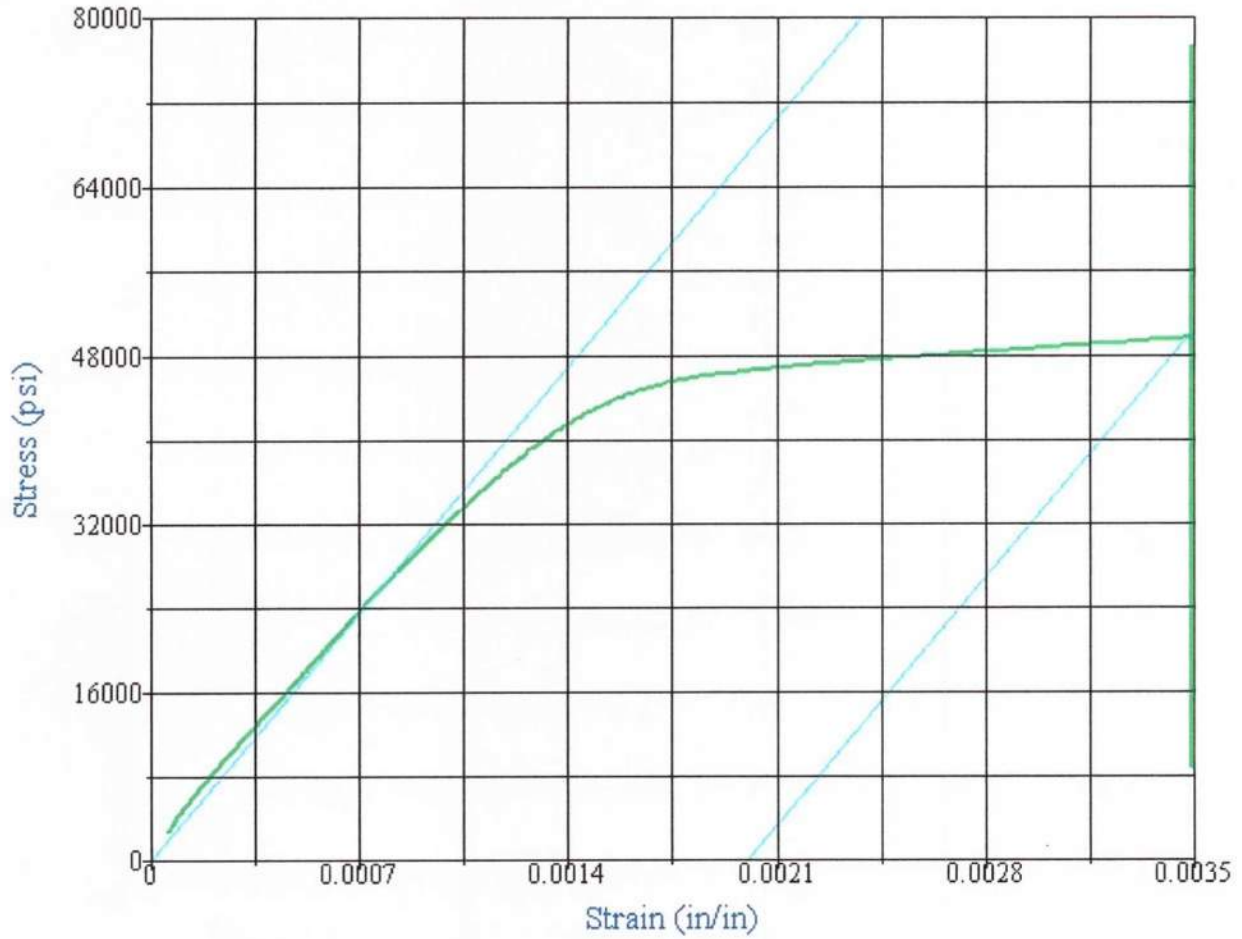
Counter: 15903
 Elapsed Time: 00:01:59
 Procedure Name: .175
 Start Date: 7/17/2018
 Start Time: 7:16:49 PM
 End Date: 7/17/2018
 End Time: 7:18:48 PM
 Workstation: Clow Water Systems
 Tested By: chad
 MyNote: product test # 1
 CM:
 PipeSize:
 Class:

Diameter: 0.1765 in
 Area: 0.0245 in²
 Peak Load: 1894 lbf
 Secant Modulus: 33575000 psi
 Load at Offset: 1216 lbf
 Tensile Strength: 77310 psi
 Total Elongation: 15.30 %
 Pretest Punch Length: .6930 in
 Posttest Punch Length: .7990 in
 Stress at Offset: 49630 psi
